3D Laser crack measurement system

Vision systems for the inspection
of transportation infrastructures

LCMS - System configuration

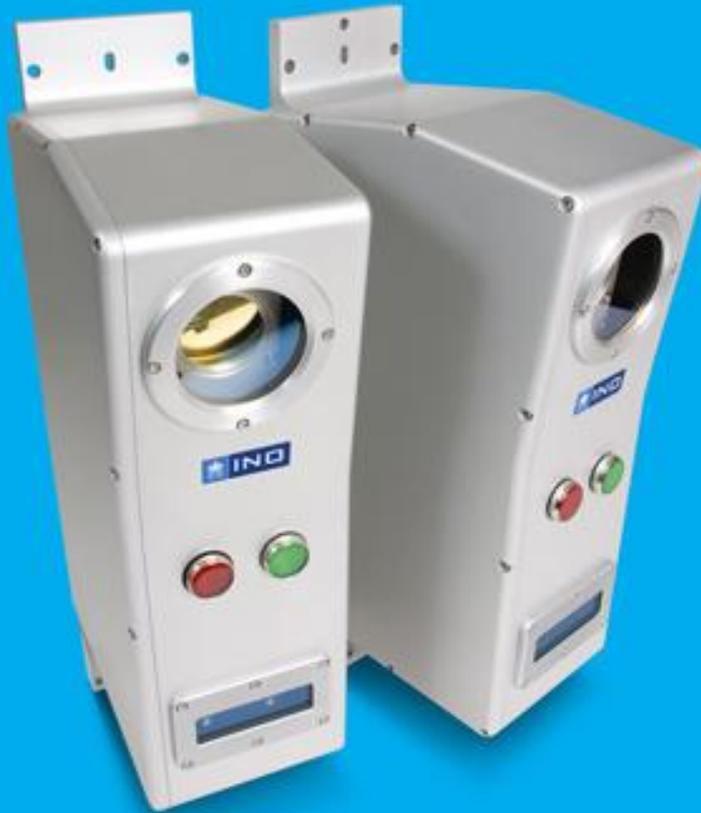
LCMS – Sensor specifications

- Profiles per second: 5600
- Points per profile: 4096
- Field of view: 4 m
- Vertical resolution: 0.5mm
- Lateral resolution: 1 mm
- Data rate:
(compressed) 720 Mb/km

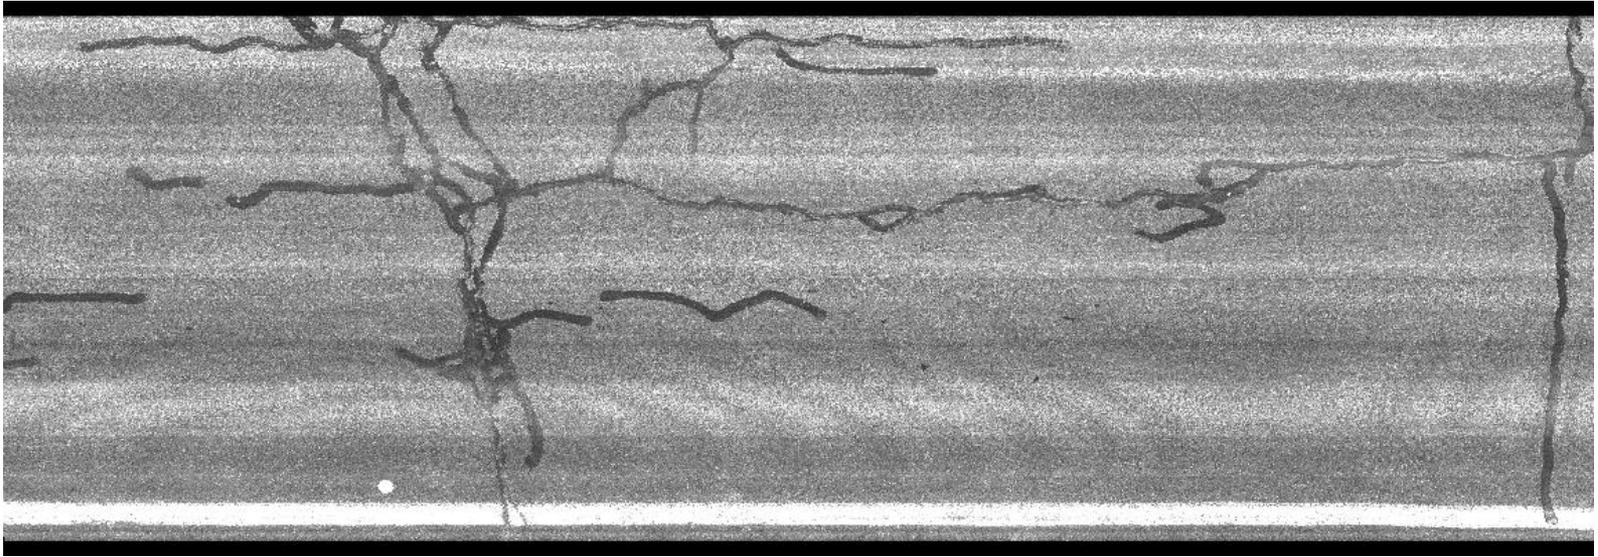
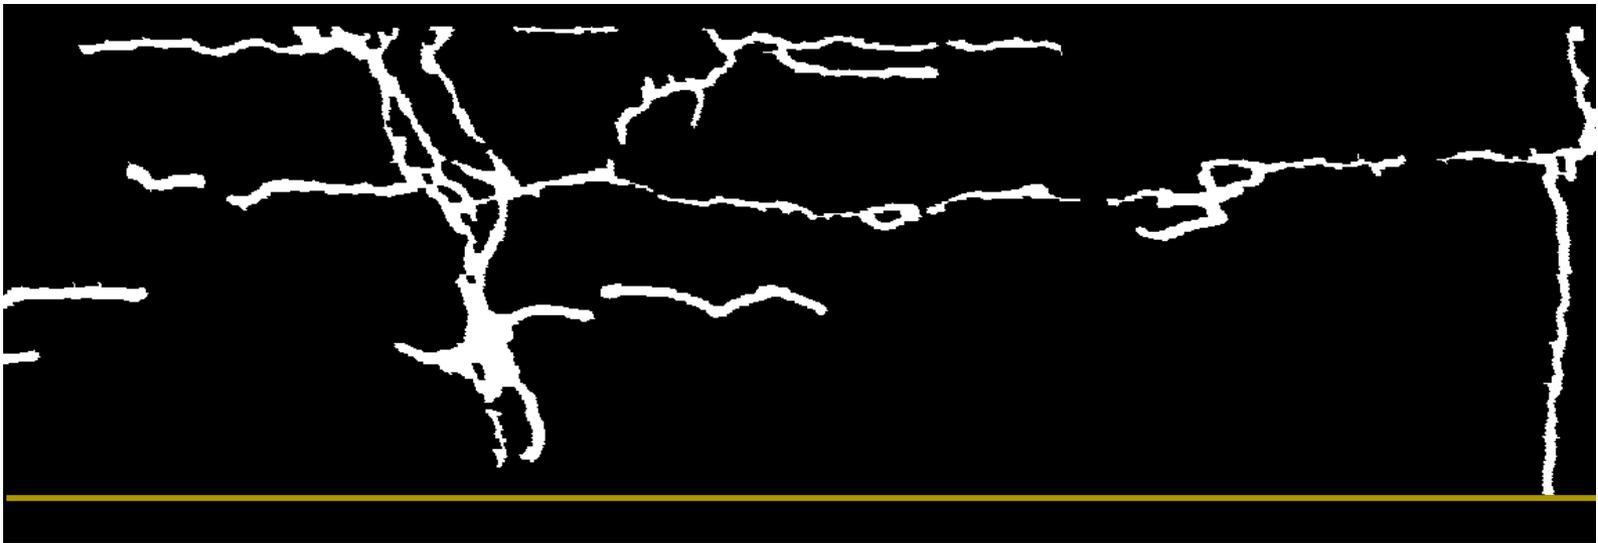
Intensity information – Lane markings, sealed cracks

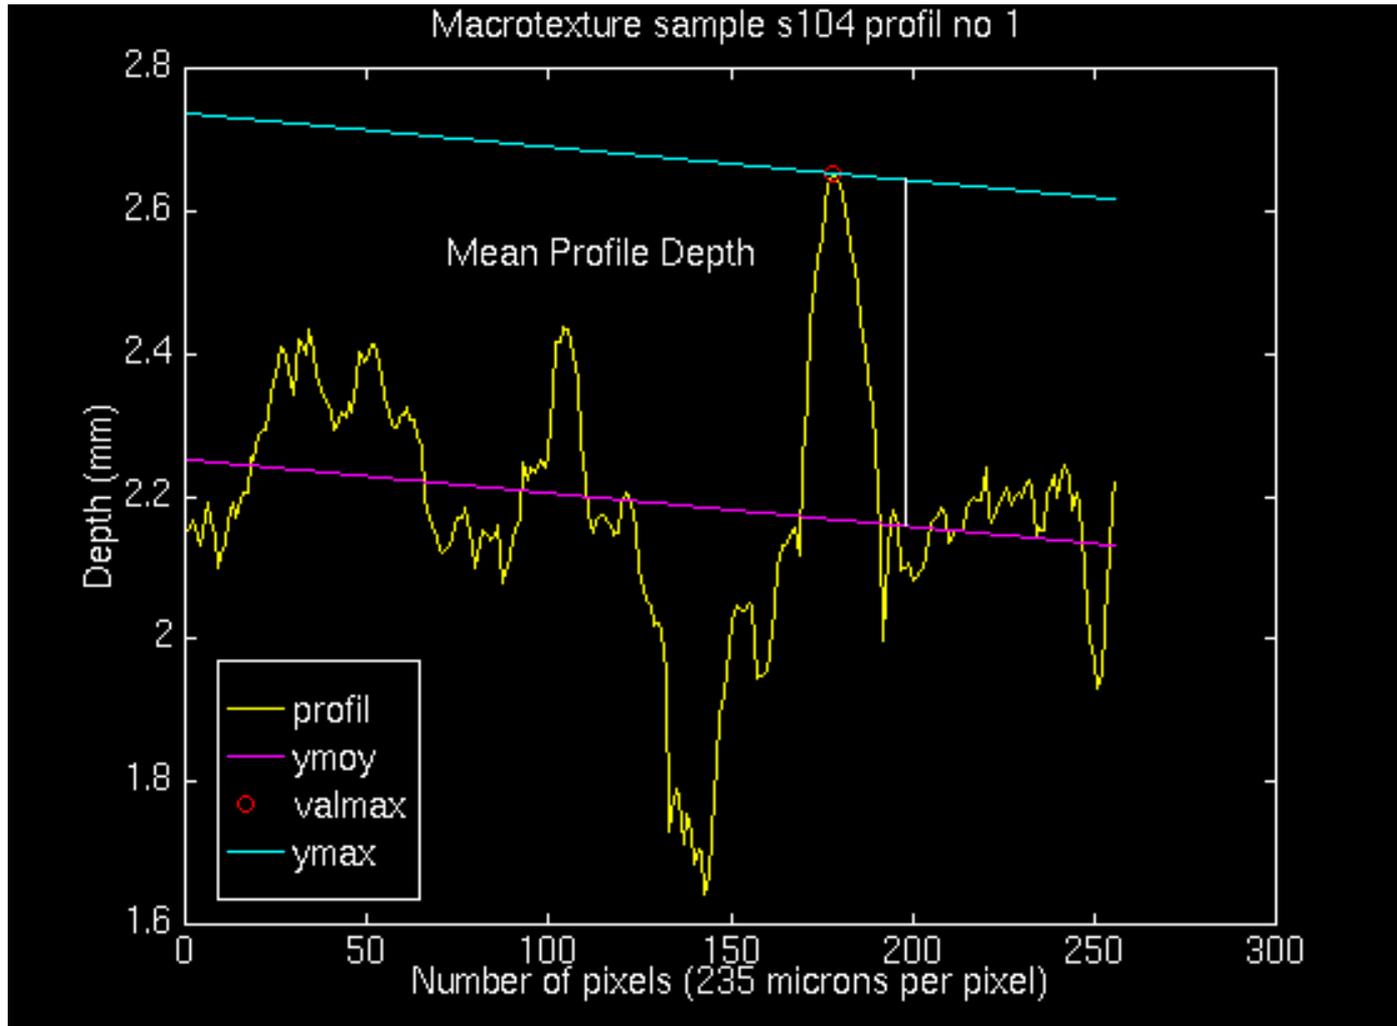
Macro-texture MPD - ASTM E1845-01

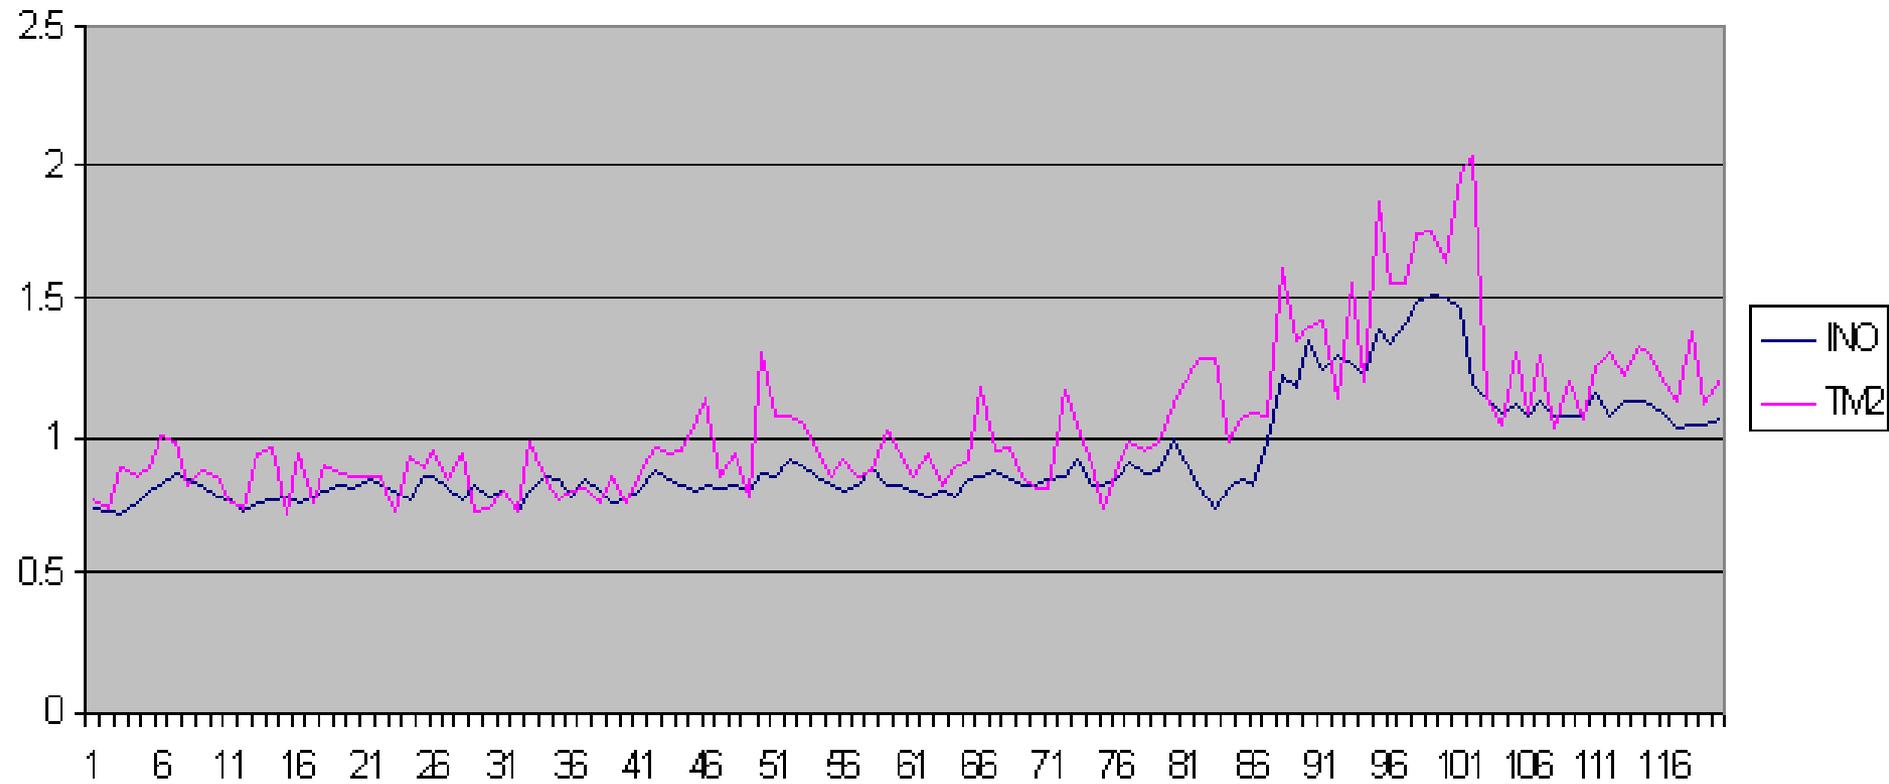
Macro-texture results (LCMS vs WDM – TM2)

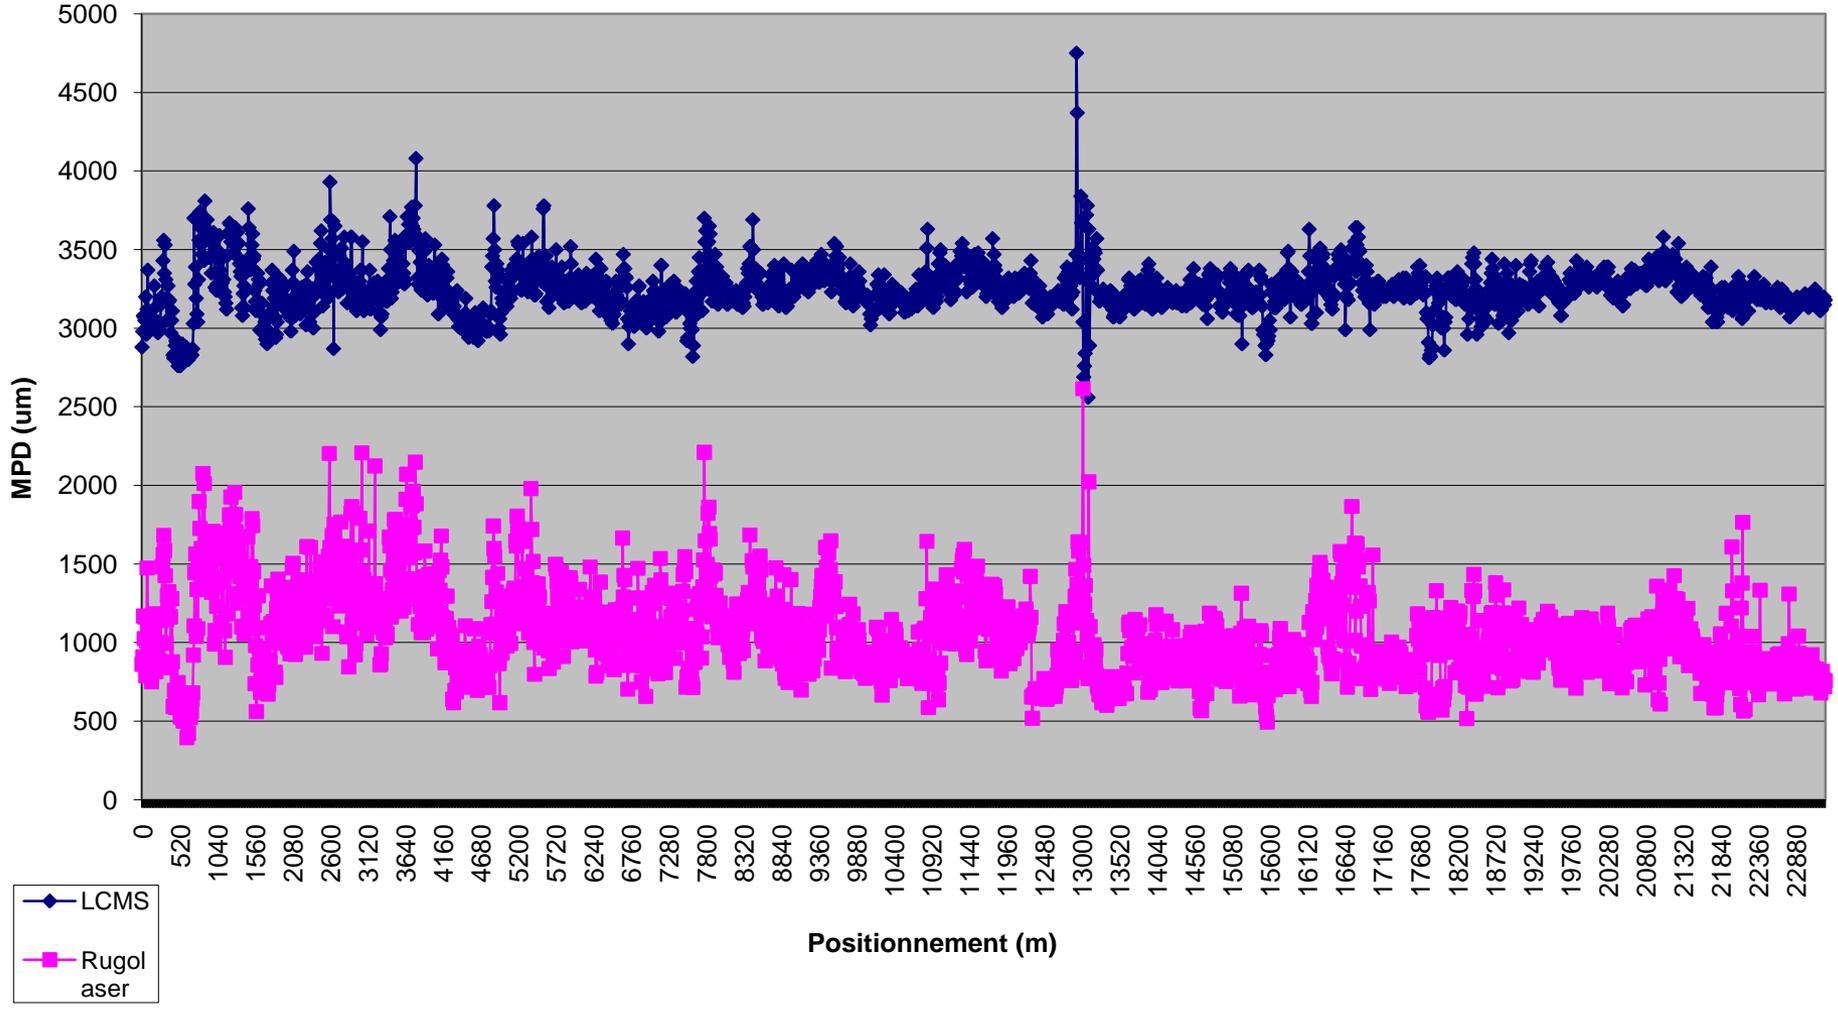
Macro-texture results (LCMS vs Dynatest)

MPD calculation results LCMS vs Dynatest (offset of 2000um)

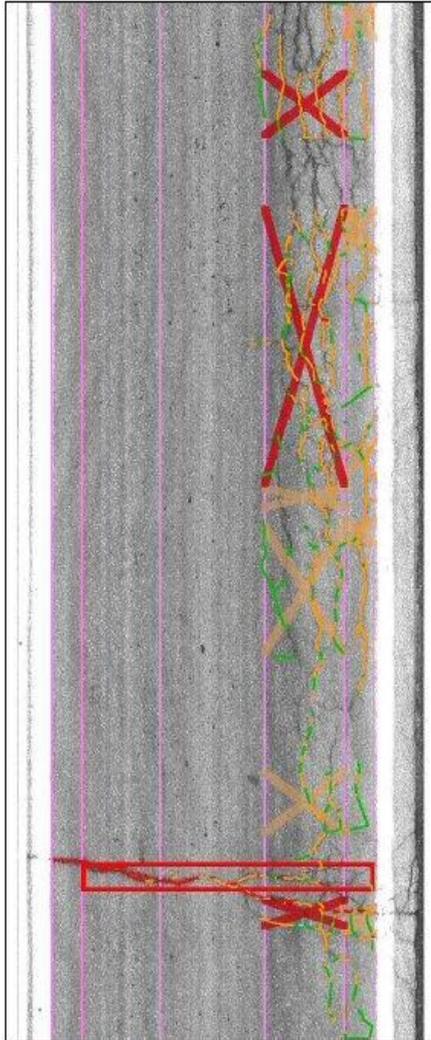
Good

Network level validation tests – criteria

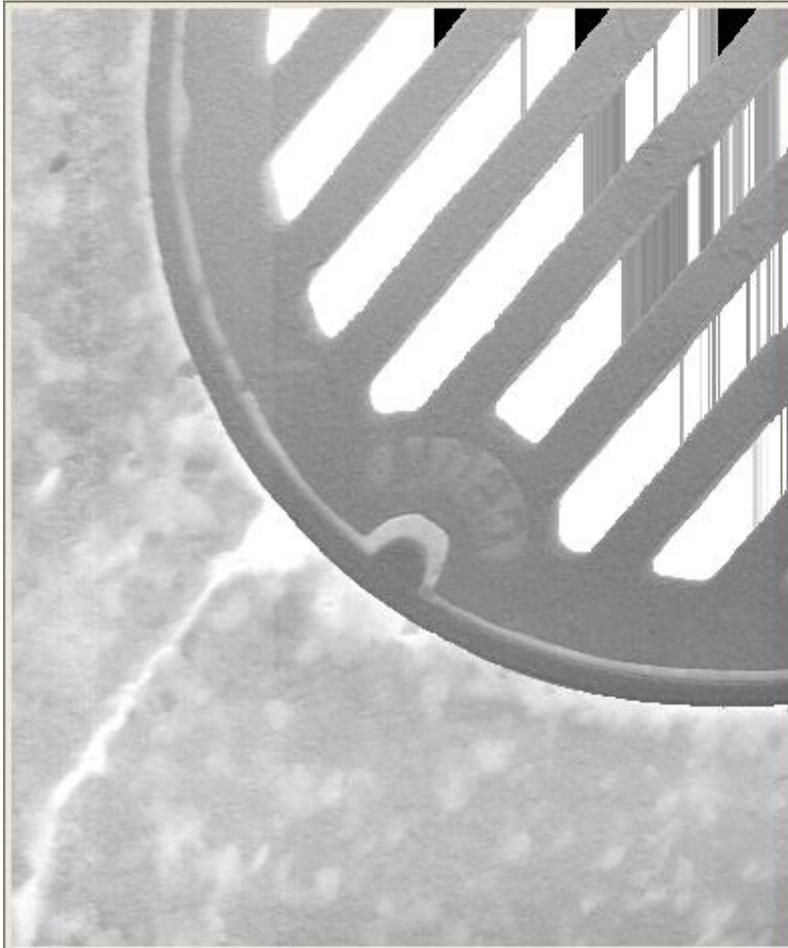
LCMS Data example – Manhole

3D Range Data

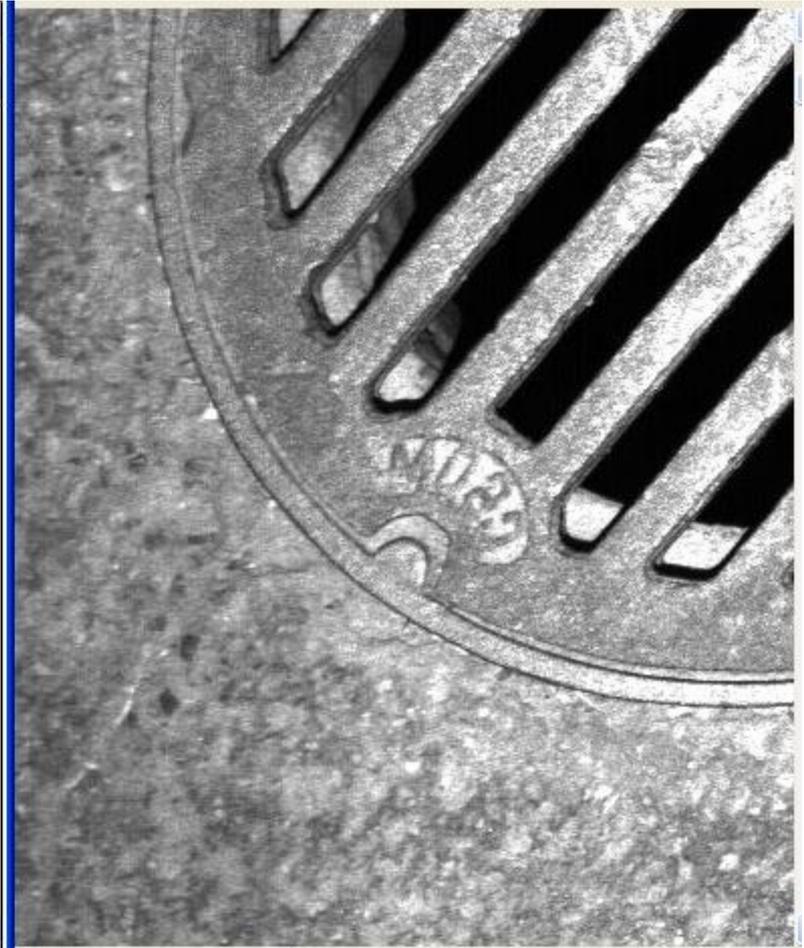
2D Intensity Data

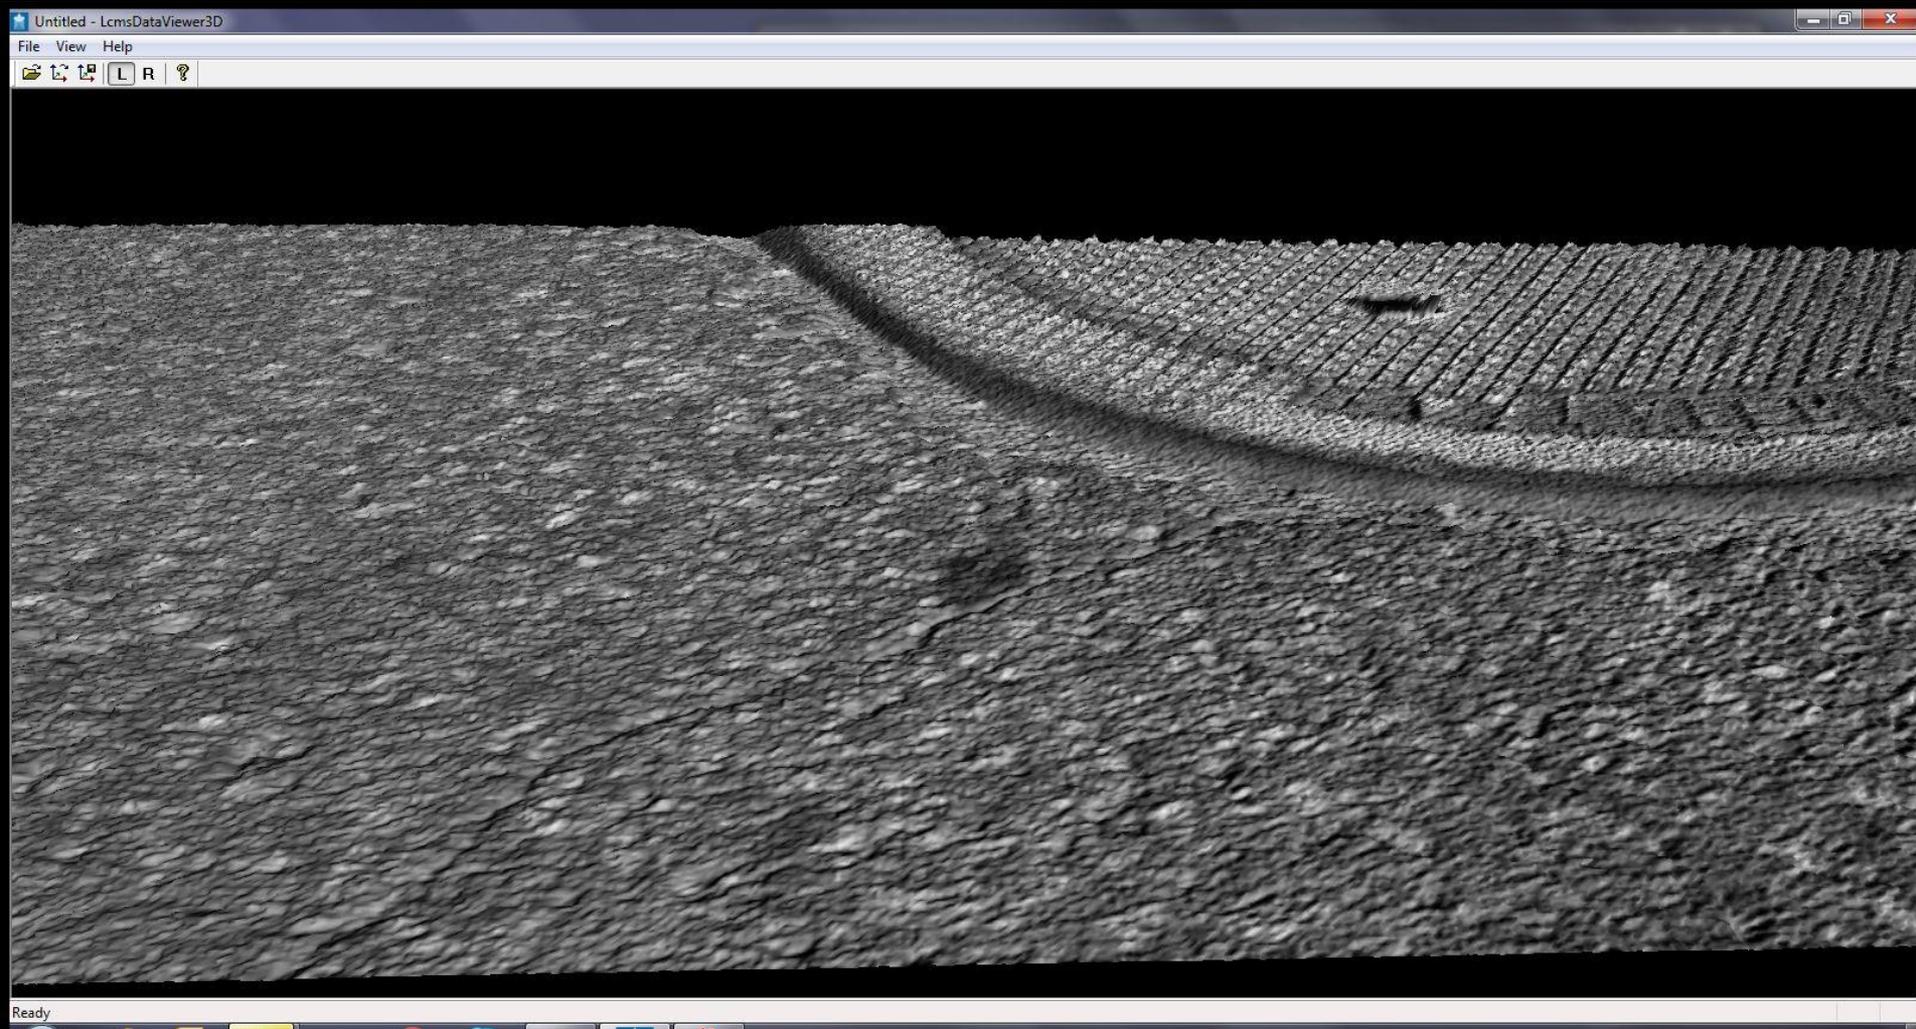
3D + 2D merged data with artificial lighting

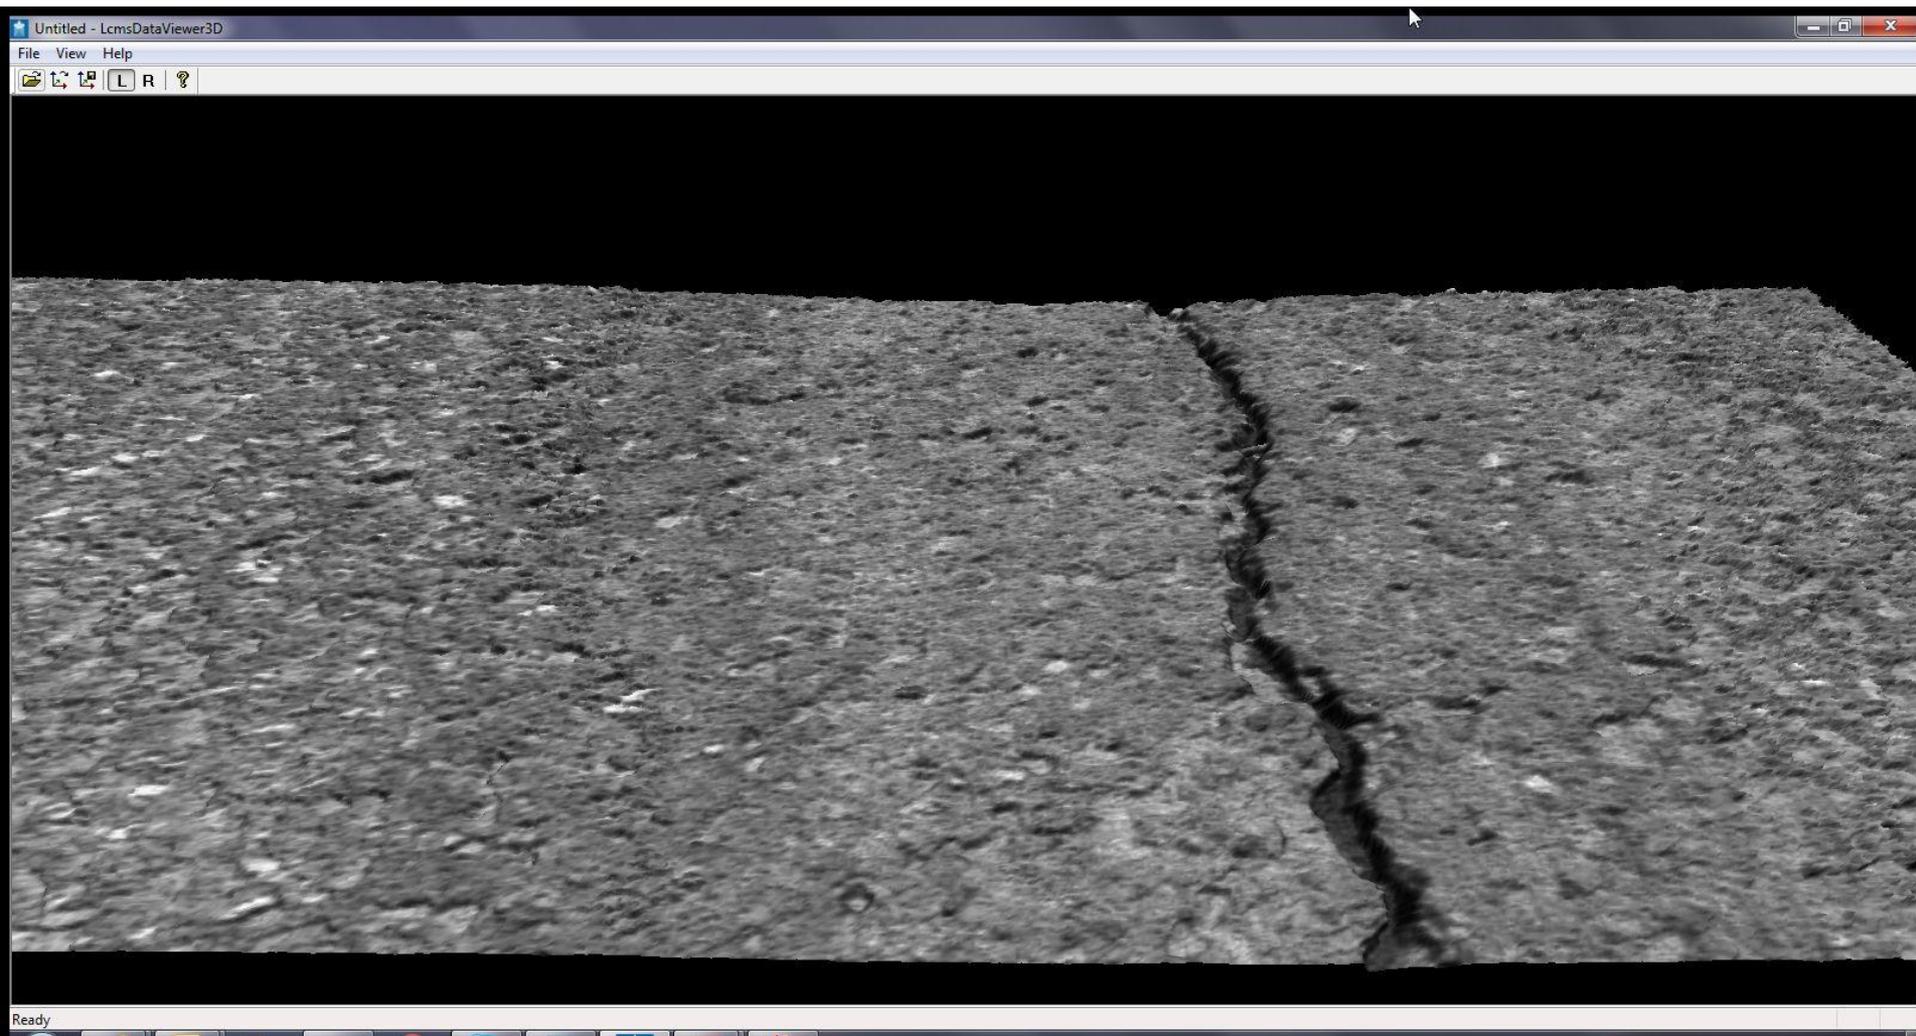
3D + 2D merged data with artificial lighting

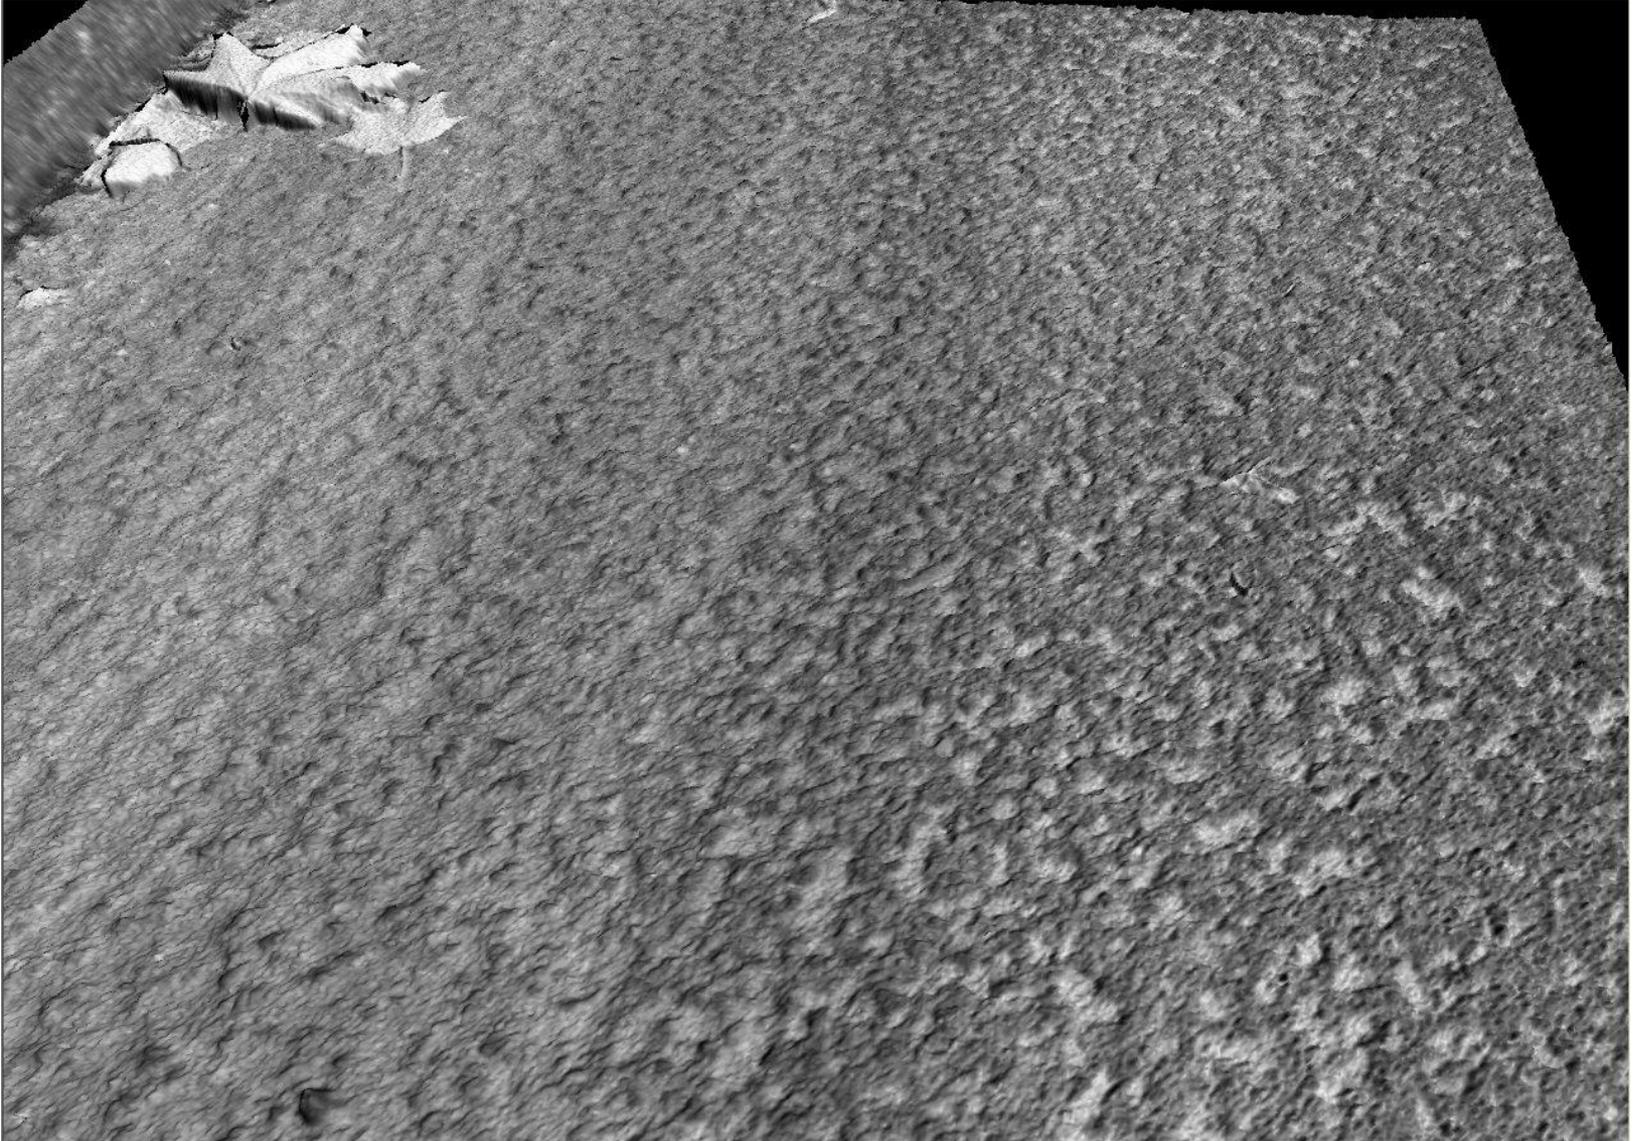
3D + 2D merged data – Maple Leaf + Texture
